# **INDOOR AIR QUALITY ASSESSMENT**

**Fitchburg Superior Court,  
Fitchburg Law Library &  
Registry of Deeds Building  
84 Elm Street  
Fitchburg, Massachusetts**

Prepared by:  
Massachusetts Department of Public Health  
Bureau of Environmental Health Assessment  
November, 2001

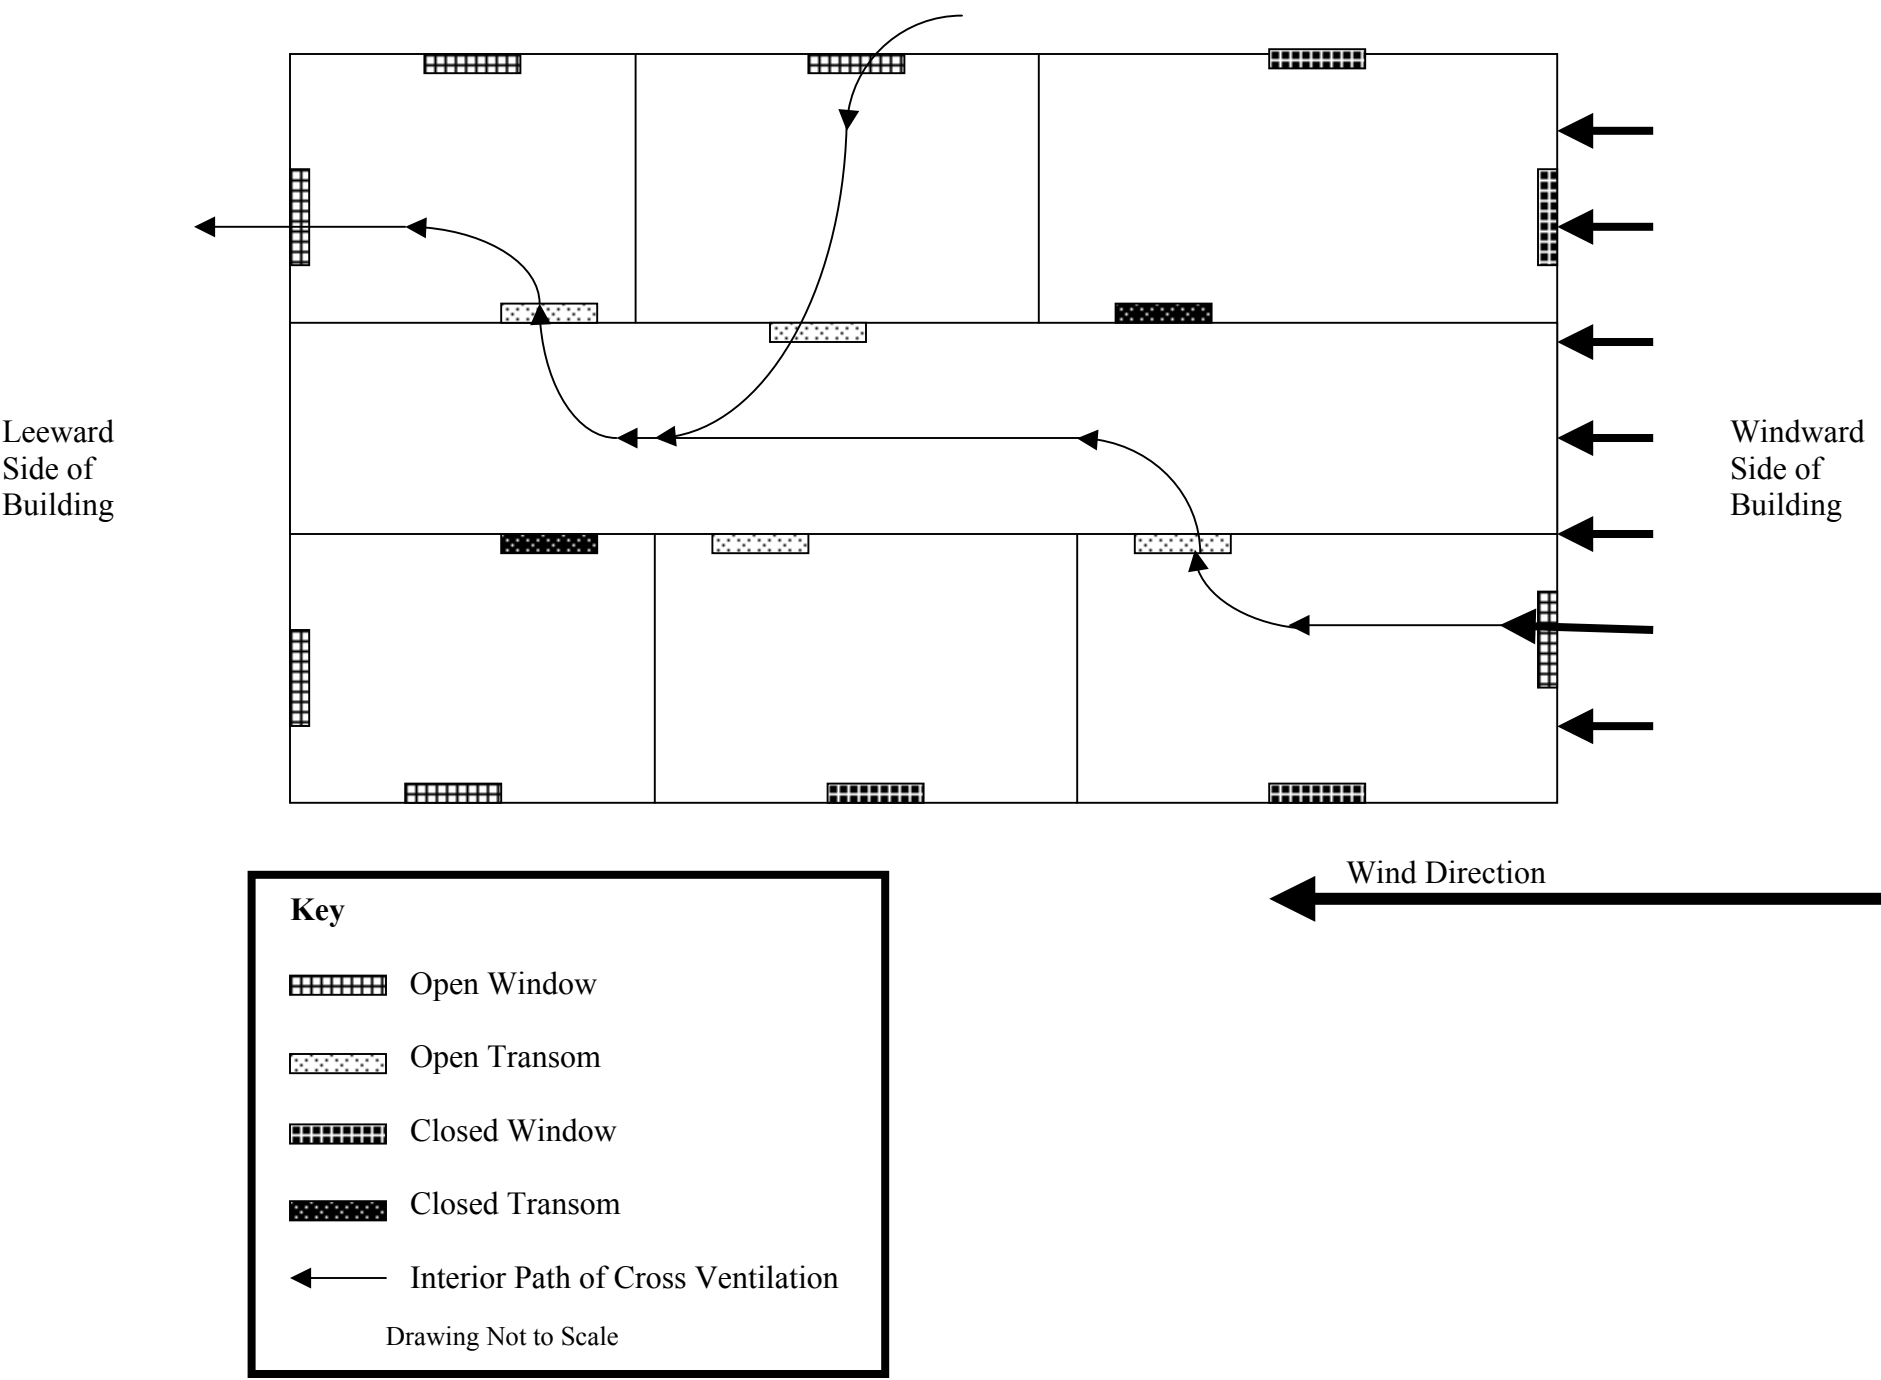
Figure 2

Inhibition of Cross Ventilation in a Building with Several Windows and Transoms Closed

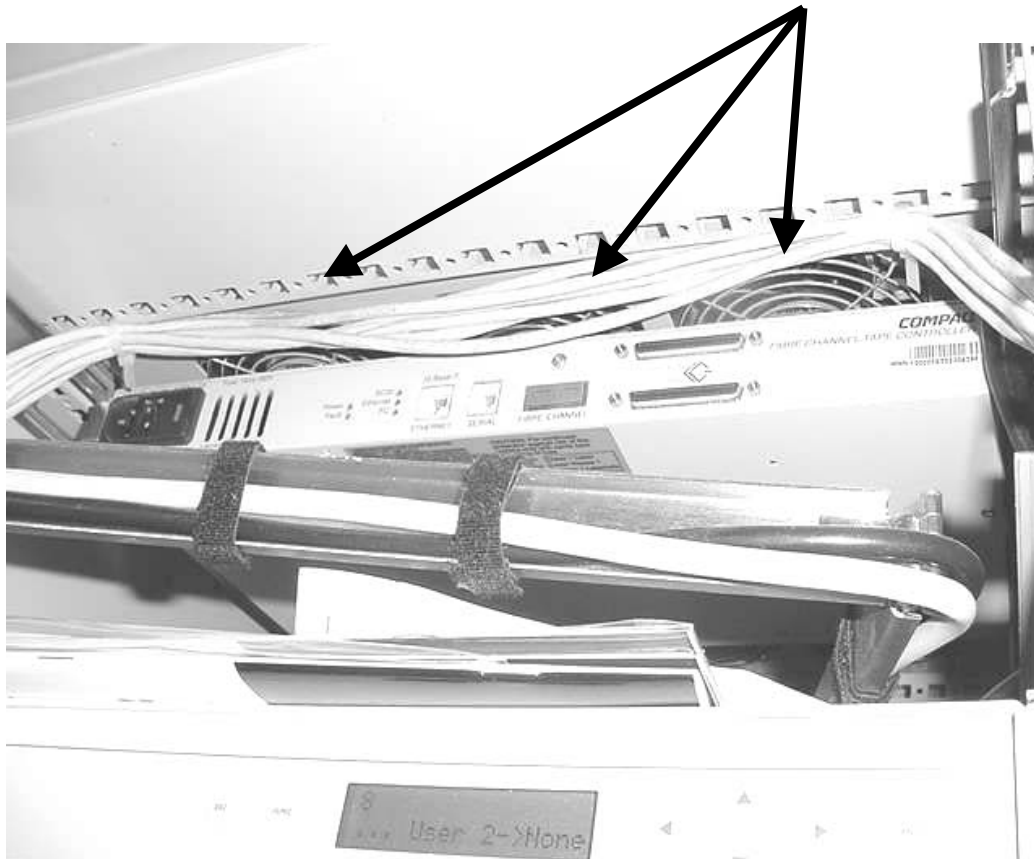
**Picture 3**

Temperature readings were measured in a range of 70° F to 74° F, which were within the BEHA recommended comfort range. The BEHA recommends that indoor air temperatures be maintained in a range of 70° F to 78° F in order to provide for the comfort of building occupants. In many cases concerning indoor air quality, fluctuations of temperature in occupied spaces are typically experienced, even in a building with an adequate fresh air supply. Concerns about lack of control over heat in the computer mainframe room were reported to BEHA staff. The room contains the mainframe for the building inside a cabinet (see Picture 2). At the top of the cabinet are fans that expel air from the cabinet into the room (see Picture 3). These fans were deactivated during the assessment.

**Deactivated Fans of the Mainframe Cabinet**

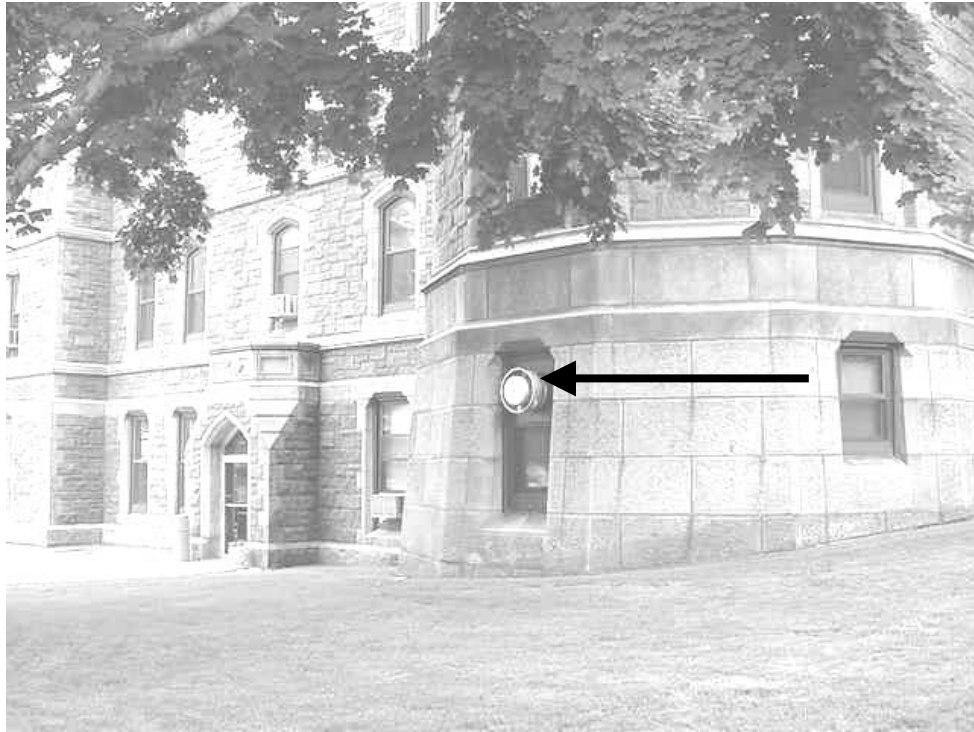
**Picture 4**

According to court staff, the ground floor was flooded by water entering through a side exterior door adjacent to the parking lot (see Picture 4), moistening wall-to-wall carpeting in the Housing Court courtroom. A contractor was called to remediate flood damage, which included drying out the carpet. The American Conference of Governmental Industrial Hygienists (ACGIH) recommends that carpeting be dried with fans and heating within 24 hours of becoming wet (ACGIH, 1989). If carpets are not dried within this time frame, mold growth may occur. Water-damaged carpeting cannot be adequately cleaned to remove mold growth. At the time of the assessment, a dehumidifier was operating in the Housing Court courtroom. Moisture measurements taken in random sections of the carpet detected no moisture. The remainder of the ground floor is bare cement floor and appeared to be free of moisture.

**Side Exterior Door Adjacent to the Parking Lot, Note Exhaust Vent for Blueprint Machine**

1. Ensure Housing Court courtroom carpeting is completely dried.
2. The building was designed to use windows to provide fresh air. In order to temper room temperature and provide fresh air, the opening of windows is recommended when WMACs are deactivated. Create cross ventilation as described in Figure 1.
3. Seal sink drain. If not practical, have office occupants or maintenance staff pour water into the drain every other day to maintain drain traps.

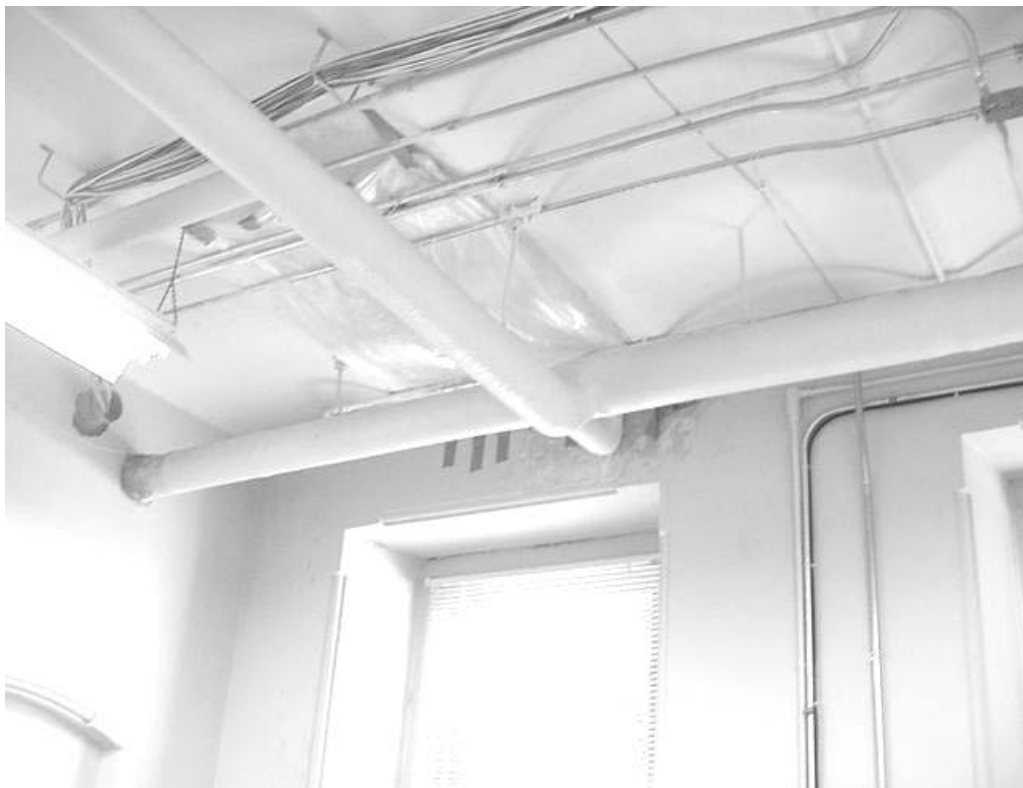
**Picture 5**

Several areas had water damaged ceiling plaster (see Picture 5). The source of water causing the damage appears to be moisture penetration through window frames and missing stone mortar (see Picture 6). Paint and porous materials moistened by penetrating water can serve as mold growth media, especially if wetted repeatedly.

**Water Damaged Ceiling Plaster, Covered With Plastic**

6. Use the exhaust vent when blueprint machine is operating.
7. Consideration should be given to pointing exterior stonework. Recaulking to window frames should also be considered.

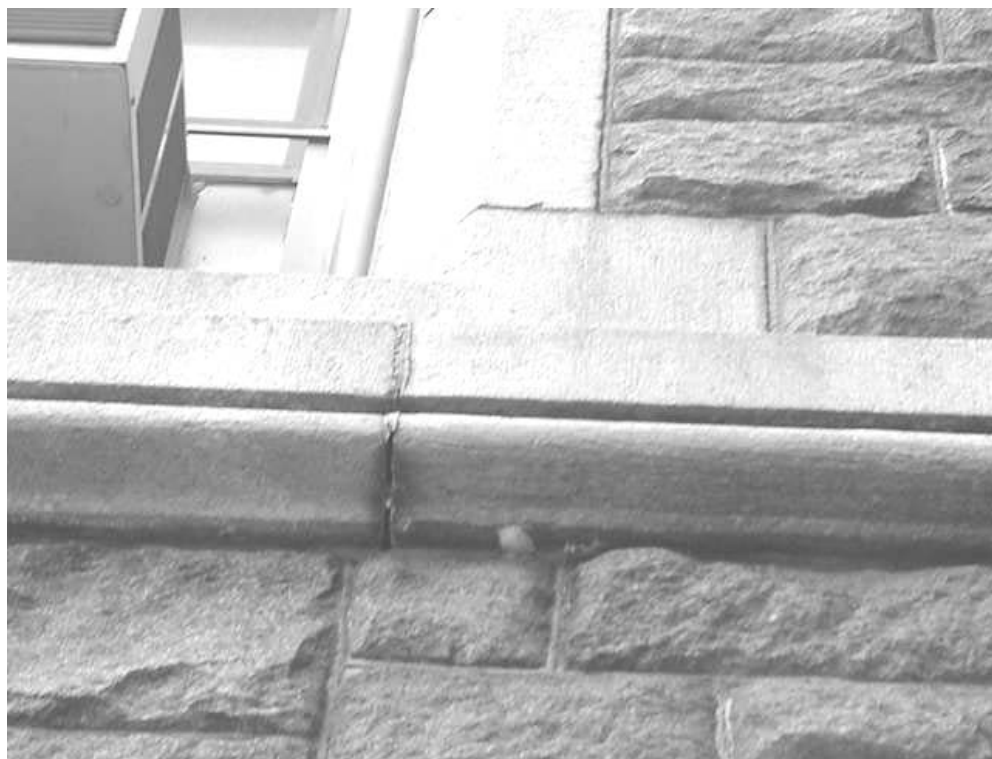
**Picture 6**

**Exterior Stonework**

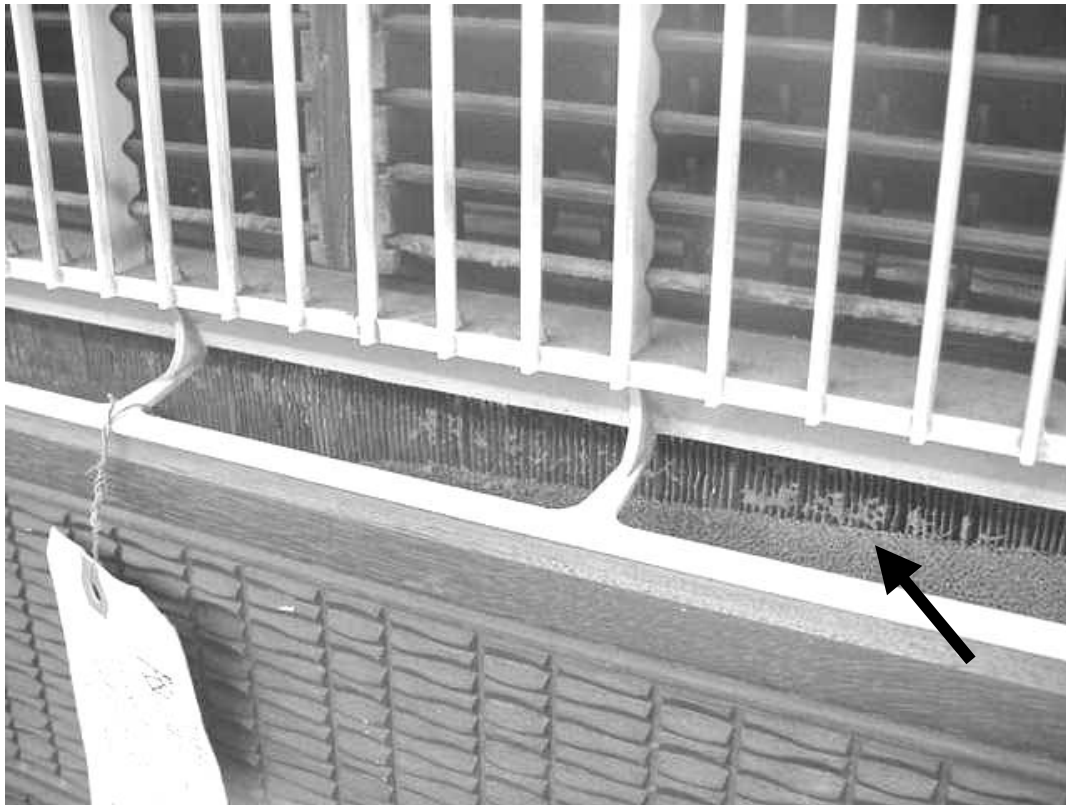
**Picture 7**

Filters in WMACs had significant amounts of accumulated dust and debris and were not installed to cover the entire surface of cooling fins (see Picture 7). The purpose of filters is to remove particulate matter from air drawn into the units. Filters need to be cleaned on a regular basis in order to maximize the efficiency of the filter. If not cleaned regularly, the filter can become saturated with dust and become a source of aerosolized

particulates when the air conditioner is operating. In order to reduce particulate aerosolization, filters should be cleaned or changed in a manner consistent with the manufacturer's recommendation.

**WAC With Improperly Installed Filter, Note Dust Accumulation on Coil Fins**

4. Clean or replace filters in WMACs in a manner consistent with the manufacturer's recommendations. In order to reduce airborne particulates, consider operating the WMACs on the "fan only" setting during cold weather. The operation of the WMACs without activating the air-cooling capacity of the equipment will both provide particulate removal and increase air circulation in office space.

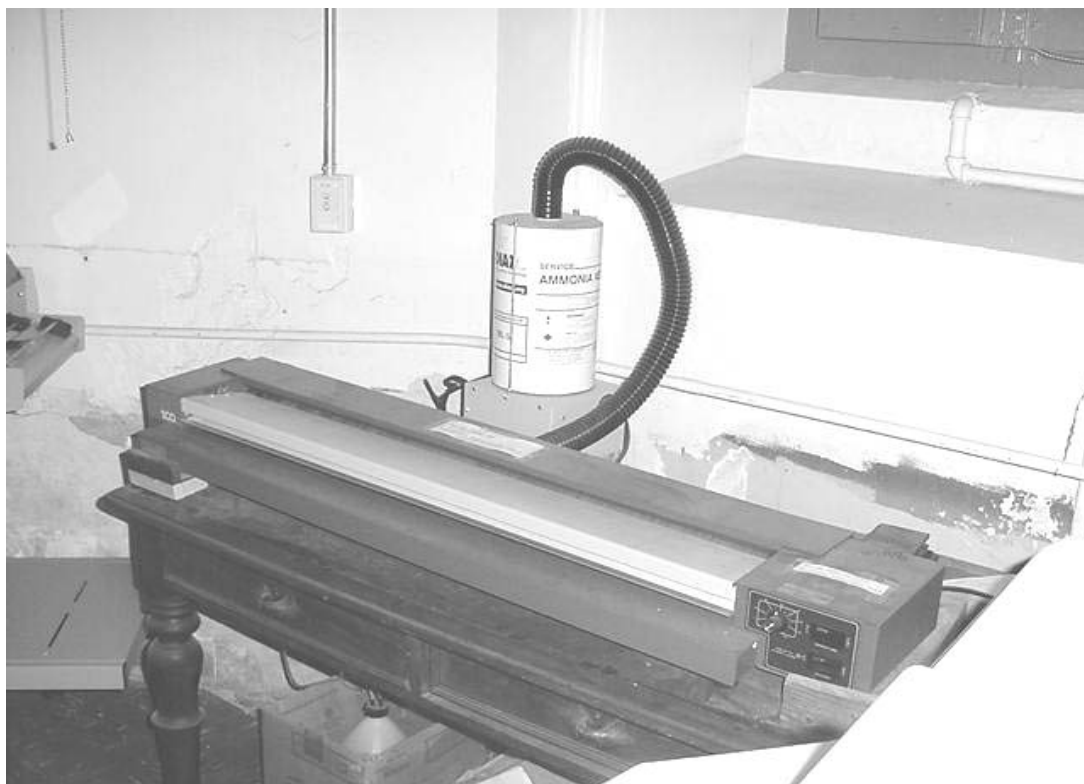
**Picture 8**

The southwest corner room of the Registry of Deeds contained a blueprint machine (see Picture 8). Blueprint machines use ammonia and can give off gas and irritating odors during use. This machinery does not appear to be in use. A large exhaust vent, presumably for use when the blueprint machine is operated, is installed over this machinery.

**Blueprint Machine**

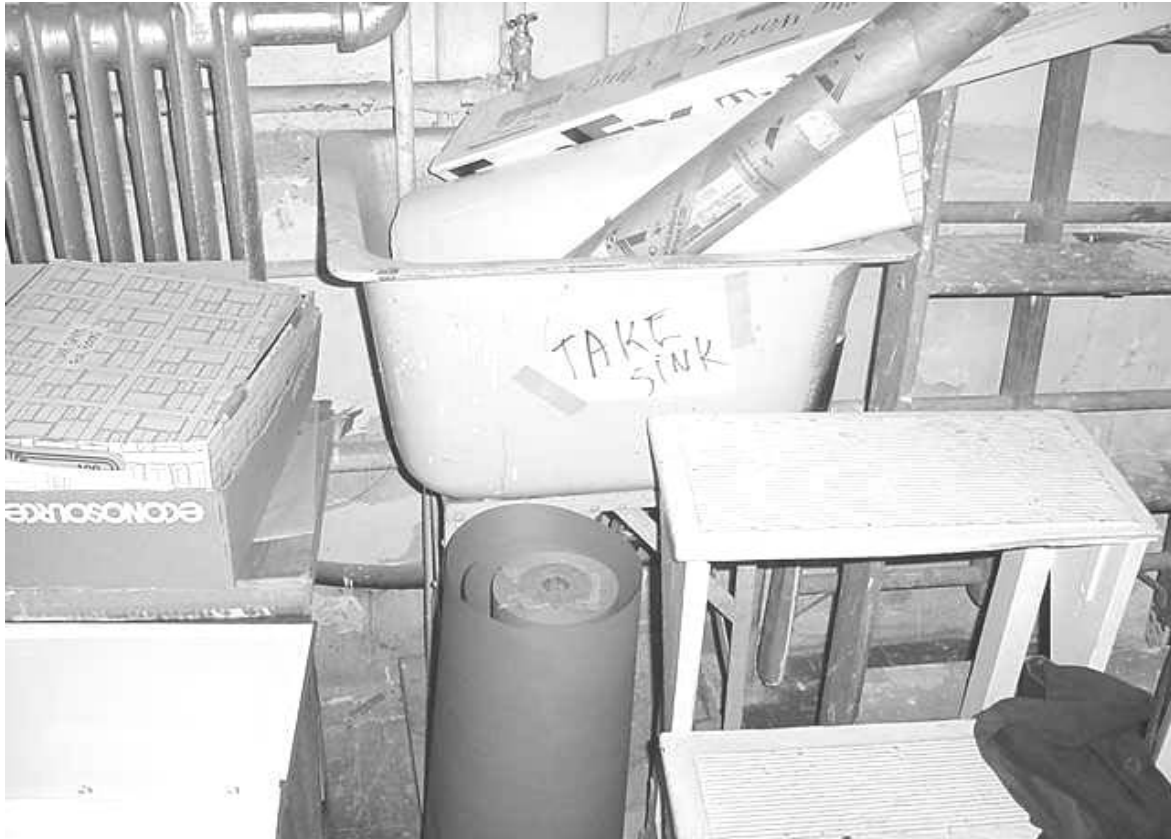
**Picture 9**

An abandoned sink is in the same area as the blueprint machine (see Picture 9). It is likely that this sink has a dry drain trap. If drain traps dry out, sewer gas can back up the drains and enter occupied areas. Sewer gas can create nuisance odors and be irritating to certain individuals.

**Abandoned Sink in the Same Area as the Blueprint Machine**
